Technical Report HL-96-18  
September 1996

# Channel Stability Study, Flamingo Wash, Las Vegas, Nevada

Prepared for U.S. Army Engineer District, Los Angeles

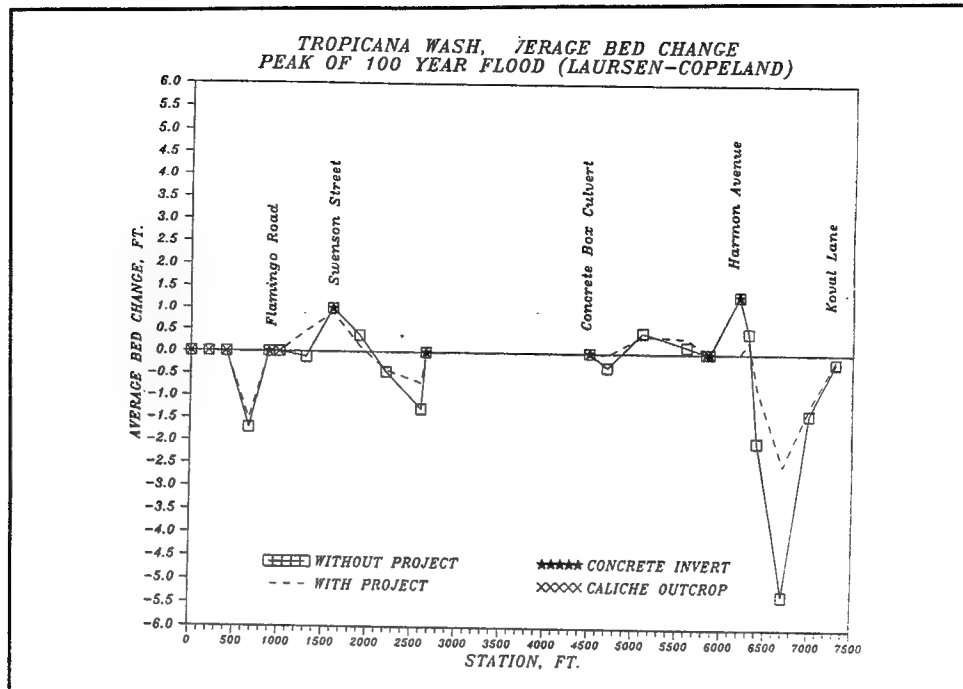
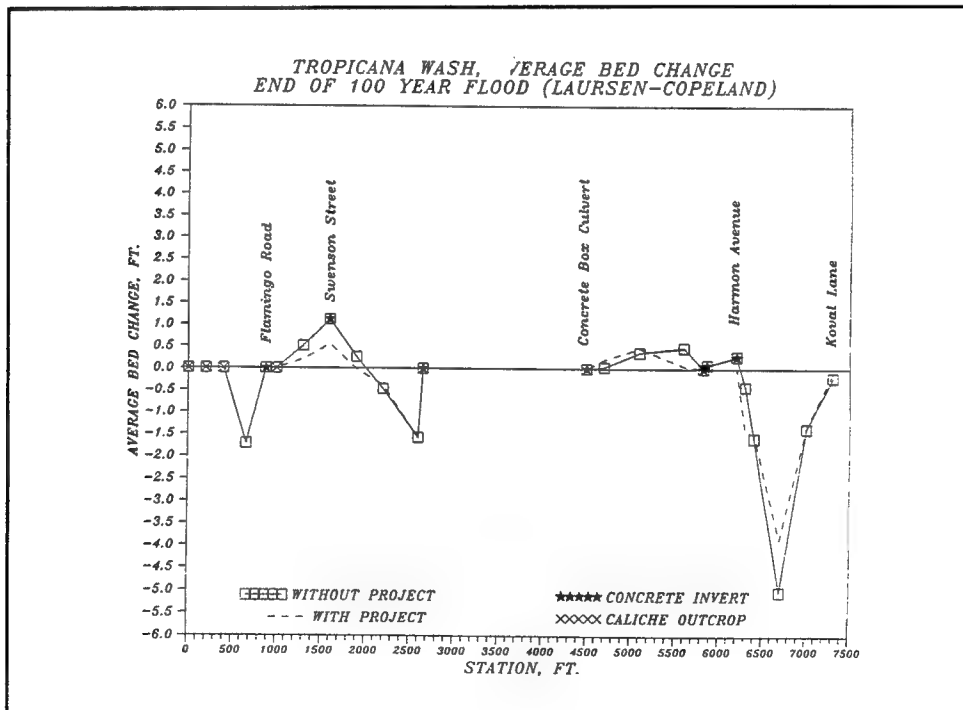
Figure 33. Calculated average bed changes, Tropicana Wash stations 0+00 to 73+00

Outflow from the proposed dam will discharge into Tropicana Wash just downstream from Koval Lane. Due to upstream diversions, the total volume of water flowing through Tropicana Wash will increase with the project, even though the peak discharges will be less. This increase in flow volume has the potential for increasing degradation. In addition, the project will reduce sediment supply to Tropicana Wash, which could further increase the potential for degradation. This reach is therefore a relatively sensitive reach. Significant degradation was calculated on Tropicana Wash downstream from Koval Lane for both with- and without-project conditions and both at the peak and at the end of the flood hydrograph. Interestingly, calculated erosion was less for the with-project condition, even though sediment inflow into Tropicana Wash was eliminated by the project. At the peak of the flood hydrograph, deposition was calculated on Tropicana Wash at Harmon Avenue where the channel size is significantly reduced. Downstream from Harmon Avenue, through the grass-lined reach 2, channel bed elevation changes are relatively small on Tropicana Wash. Some degradation occurs in the channel as it exits the culvert downstream from Paradise Road, but the degradation is limited by caliche outcrops. Degradation potential is high on Tropicana Wash downstream from Flamingo Road, but caliche outcrops will tend to hold the

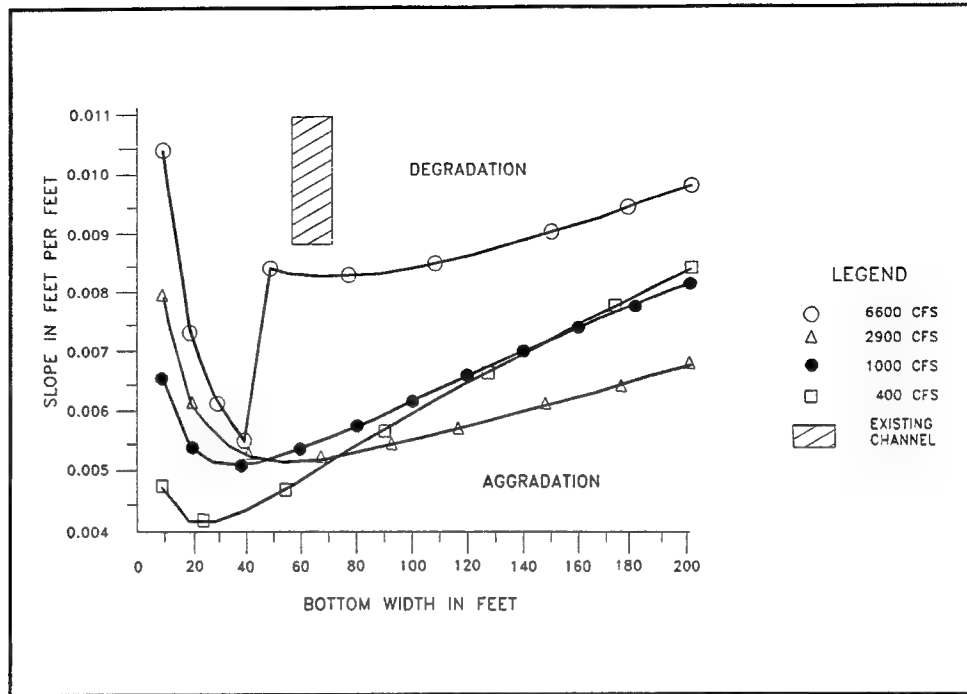
Figure 45. Channel stability curve - Flamingo Wash, Reach 13

The first reach downstream from reach 11 was a concrete-lined channel and required no analysis. The next reach, reach 13, between Mojave Road and Vegas Valley Drive, was a graded trapezoidal channel with a cut low-flow channel. The stable channel analytical method was applied to this reach to obtain a preliminary design estimate of stable channel dimensions. The proposed channel design was a trapezoidal channel that retained the unlined 1V:3H side slopes, which were assigned a roughness coefficient of 0.040. The stable channel calculations were made using the hydraulic design package SAM. The calculated stable channel design curves are shown in Figure 45. Also shown on this figure are the base width and slope ranges of the existing channel. The existing channel dimensions plot well above the stability curves for all discharges, indicating an existing channel regime subject to degradation. Since the existing channel passes through a residential neighborhood, it would be difficult to widen the channel. Therefore, retaining the existing channel base width of about 60 ft, a design channel slope of 0.0050 is obtained from the stability curves for 2,900 cfs. The estimated design slope is about 50 percent of the existing channel slope. An 11-ft drop would be required through the 2000-ft-long reach to attain this slope. Calculated water depth at 2,900 cfs is 5.8 ft, average channel velocity is 6.4 ft/sec, and the composite roughness coefficient is 0.046. This high roughness coefficient is the result of bed-form roughness calculated by the Brownlie equations. The discontinuity in the stability curve for 6600 cfs is due to transition from upper regime plane bedforms to lower regime dune bedforms.

The stable channel method only provides for sediment transport capacity through the reaches. In all the reaches studied herein, the calculated channel velocity was higher than the maximum permissible velocities. Therefore, bank protection would be required for all these stable channel designs.

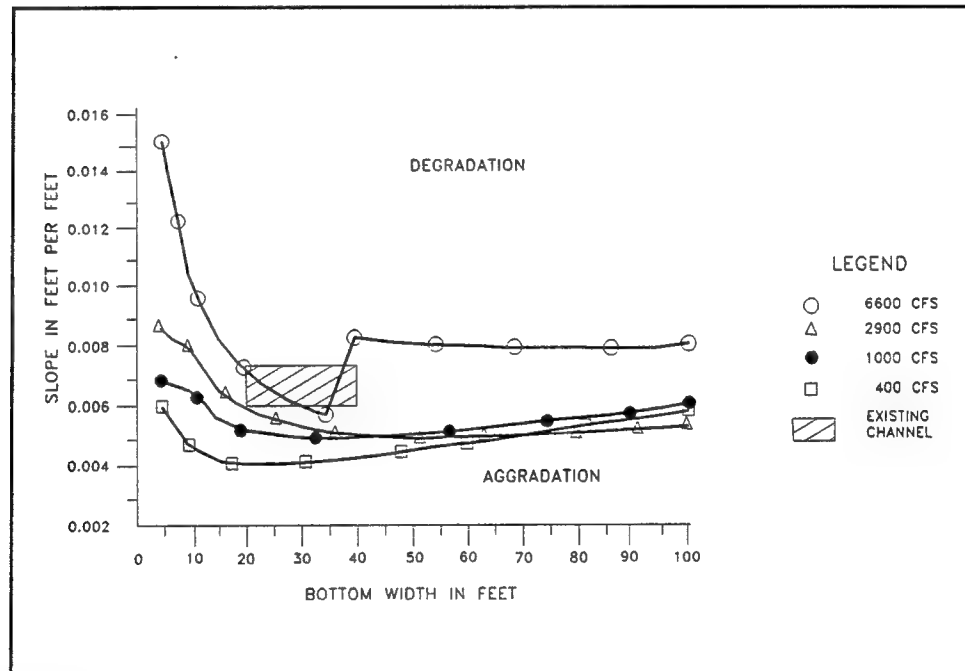
Figure 46. Channel stability curve - Flamingo Wash, Reach 14

The stable channel method was applied to the next reach downstream, reach 14, located between Vegas Valley Drive and Boulder Highway. The existing channel in this reach is generally trapezoidal in shape with irregular 1V:2H bank slopes. The design channel was assumed to retain the same shape as the existing channel. The banks were assigned a roughness coefficient of 0.050. For design purposes, sediment inflow was assumed to come from reach 11. The calculated stability curves are shown in Figure 46. Also shown are the ranges of slope and base width in the existing channel. The existing channel dimensions fall above the stability curves for all discharges except the one-percent-chance exceedance peak. This indicates that the channel would be relatively stable during the peak of the one-percent-chance exceedance hydrograph but would be subject to degradation at the other discharges. Using an average channel base width of 30 ft, which matches the existing channel, a design slope of 0.0053 is suggested for 2,900 cfs. This is only a 15 percent decrease from the existing channel slope. A 1.5-ft drop would be required in this 1600-ft-long reach to attain this slope. Calculated water depth at 2,900 cfs is 8.7 ft, average channel velocity is 7.0 ft/sec, and the composite roughness coefficient is 0.051. This high roughness coefficient is the result of bed-form roughness calculated by the Brownlie equations.

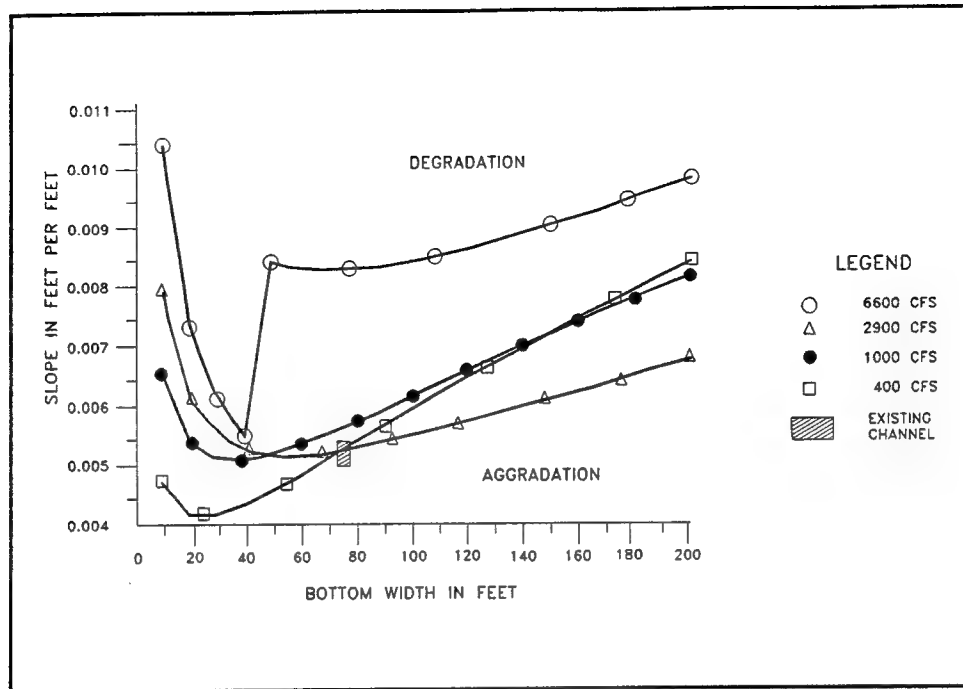
Figure 47. Channel stability curve - Flamingo Wash, Reach 16

Between Interstate-515 and Lamb Boulevard is reach 16, an unlined trapezoidal channel with 1V:3H side slopes. The same channel shape was assumed for the stable channel design. A bank roughness coefficient of 0.040 was assigned. Reach 16 has the same stability curves as reach 13 because the channel side slopes are the same and the sediment supply reach is the same. The stability curves are shown in Figure 47 with the existing channel ranges of slope and base width. The stability curves indicate that the existing channel should be stable for all discharges, except the one-percent-chance exceedance discharge. At a discharge 6,600 cfs, aggradation is predicted. The analysis suggests that the existing slope of about 0.0052 and base width of 75 ft be retained. For a discharge of 2,900 cfs, calculated water depth is 5.2 ft, average channel velocity is 6.1 fps, and the composite roughness coefficient is 0.047.

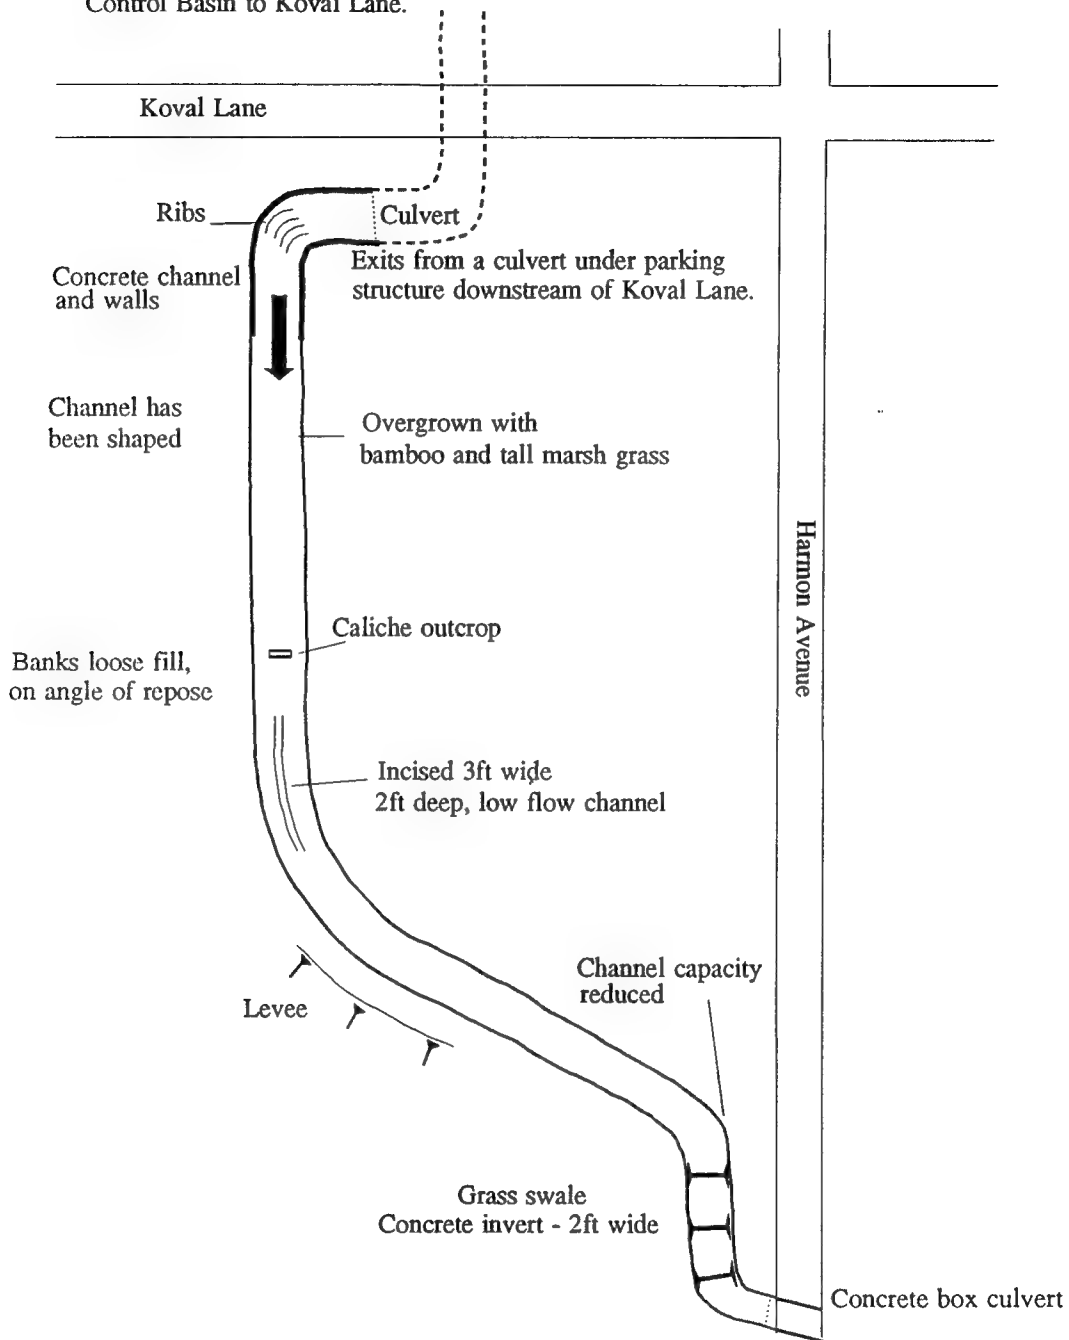
**REACH 1**  
**KOVAL LANE TO HARMON LANE**

bamboo. Further downstream, over the next 200 ft, the channel was vegetated with shrubs and bushes, and the banks consisted of loose fill. There appeared to be a caliche outcrop in the bed about 250 ft downstream from the concrete-lined channel. At the mid-point between Koval Lane and Harmon Avenue, where the channel curved to the left, there appeared to be a short levee on the right bank protected by concrete rubble. An incised low-flow channel that was about 3 ft wide and 2 ft deep was observed at this location. As the channel approached Harmon Avenue, its capacity decreased significantly. The reduced capacity channel made a tight right turn and paralleled Harmon Avenue for about 200 ft. Adjacent to Harmon Avenue the channel was a grassed swale with a 2-ft-wide concrete invert. Due to the limited capacity of the grassed swale and the tight bend upstream it is expected that flood flows would leave the channel and flow eastward down Harmon Avenue. It is also expected that some of the flood breakout would be captured again on the downstream side of Harmon Avenue. A six-bay concrete-box culvert passed under Harmon Avenue. It had a total height of 8.3 ft, and in August 1994 about 1 ft of mud had deposited on the culvert invert. Plate 3 is a plan view sketch of the reach.

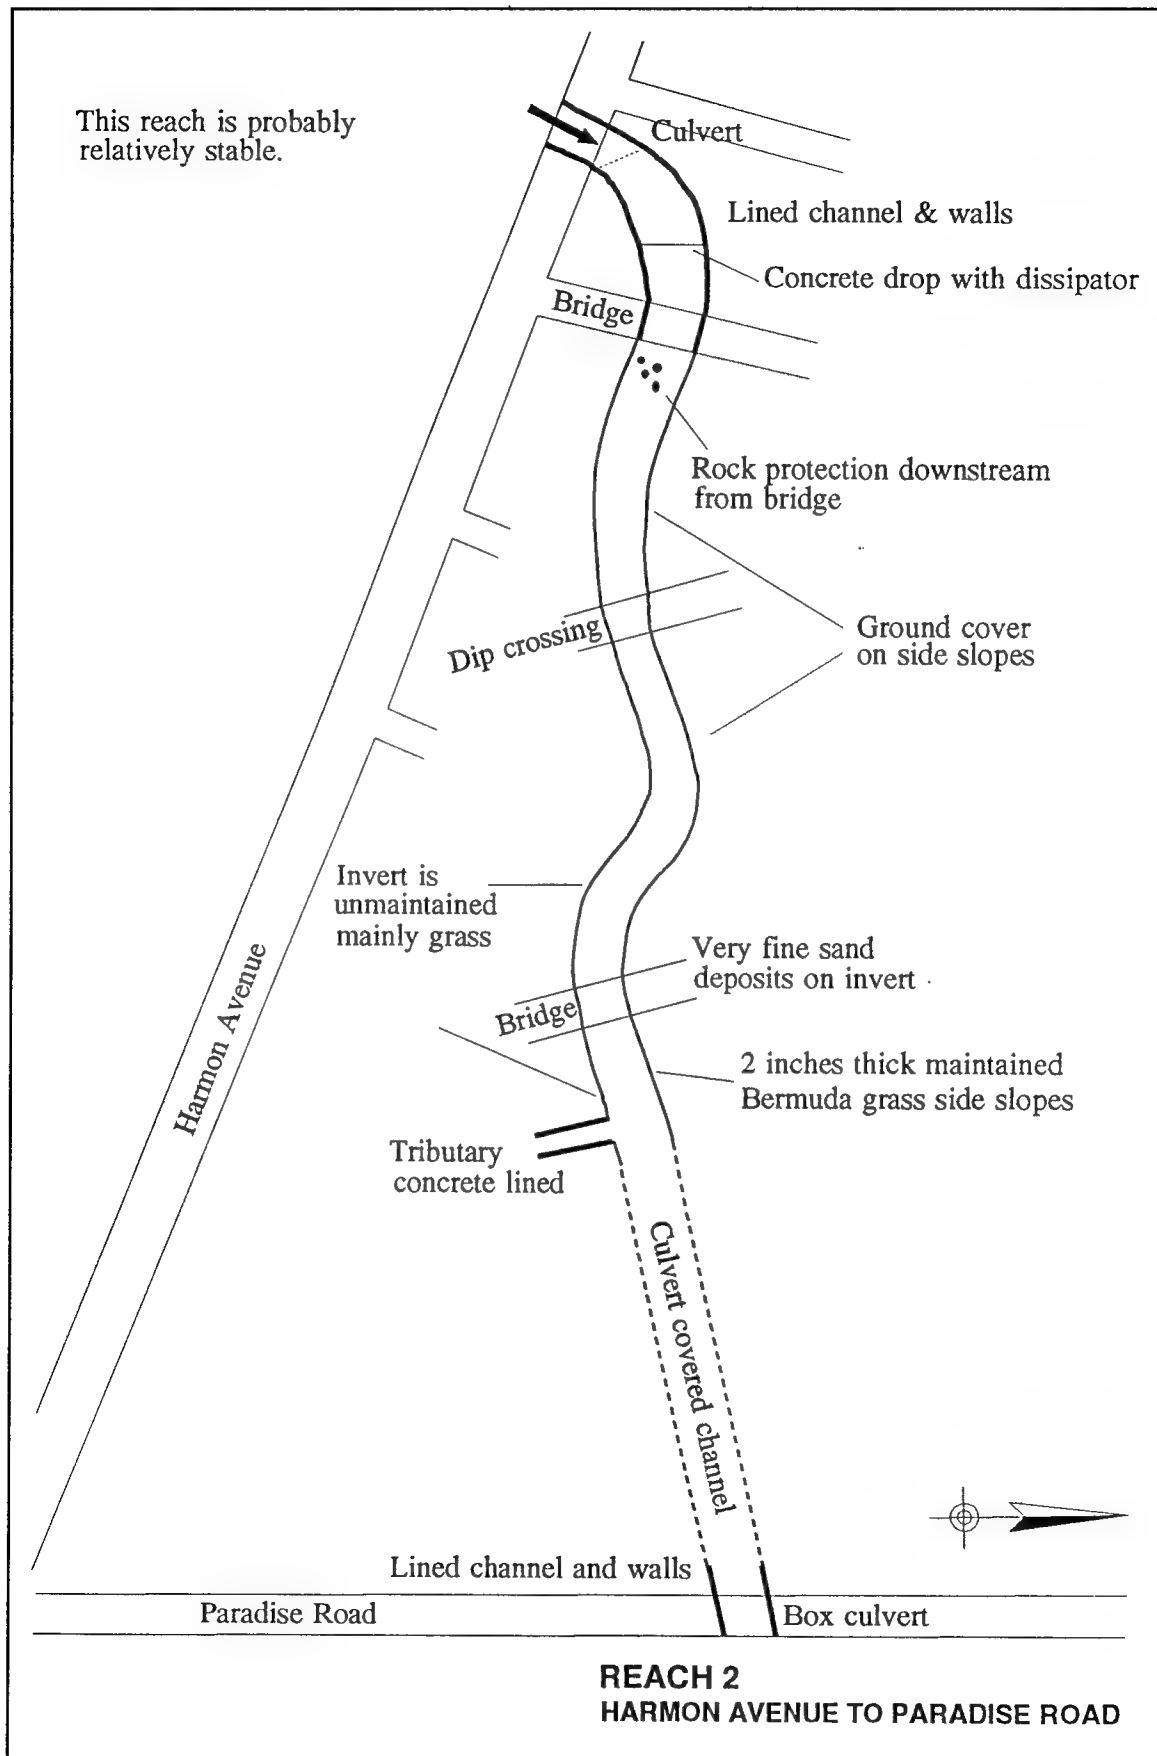
Plate 4

Downstream from Harmon Avenue, for about 150 ft, the channel was concrete-lined. At the end of the concrete-lined channel there was a 3- to 4-ft drop structure and an energy dissipator (Figure 2). Downstream from the dissipator the channel was grass-lined. Low vegetative ground cover was maintained on the side slopes between a driveway bridge, located about 250 ft downstream from Harmon Avenue, and a point 900 ft downstream from Harmon Avenue (Figure 3). Downstream from that point, both the invert and side slopes were grass-lined. Most of the grass in the channel was well maintained in August 1994, but there were a few spots where it had died and bare ground was exposed. Underneath the driveway bridge there were large cobbles and boulders that looked like they had been positioned to hold the low-flow channel. A paved dip road crossing was located about 600 ft downstream from Harmon Avenue. The grass-lined channel runs into a concrete multi-bay culvert which is located 1400 ft downstream from Harmon Avenue. The features described for reach 2 are shown in Plate 4.

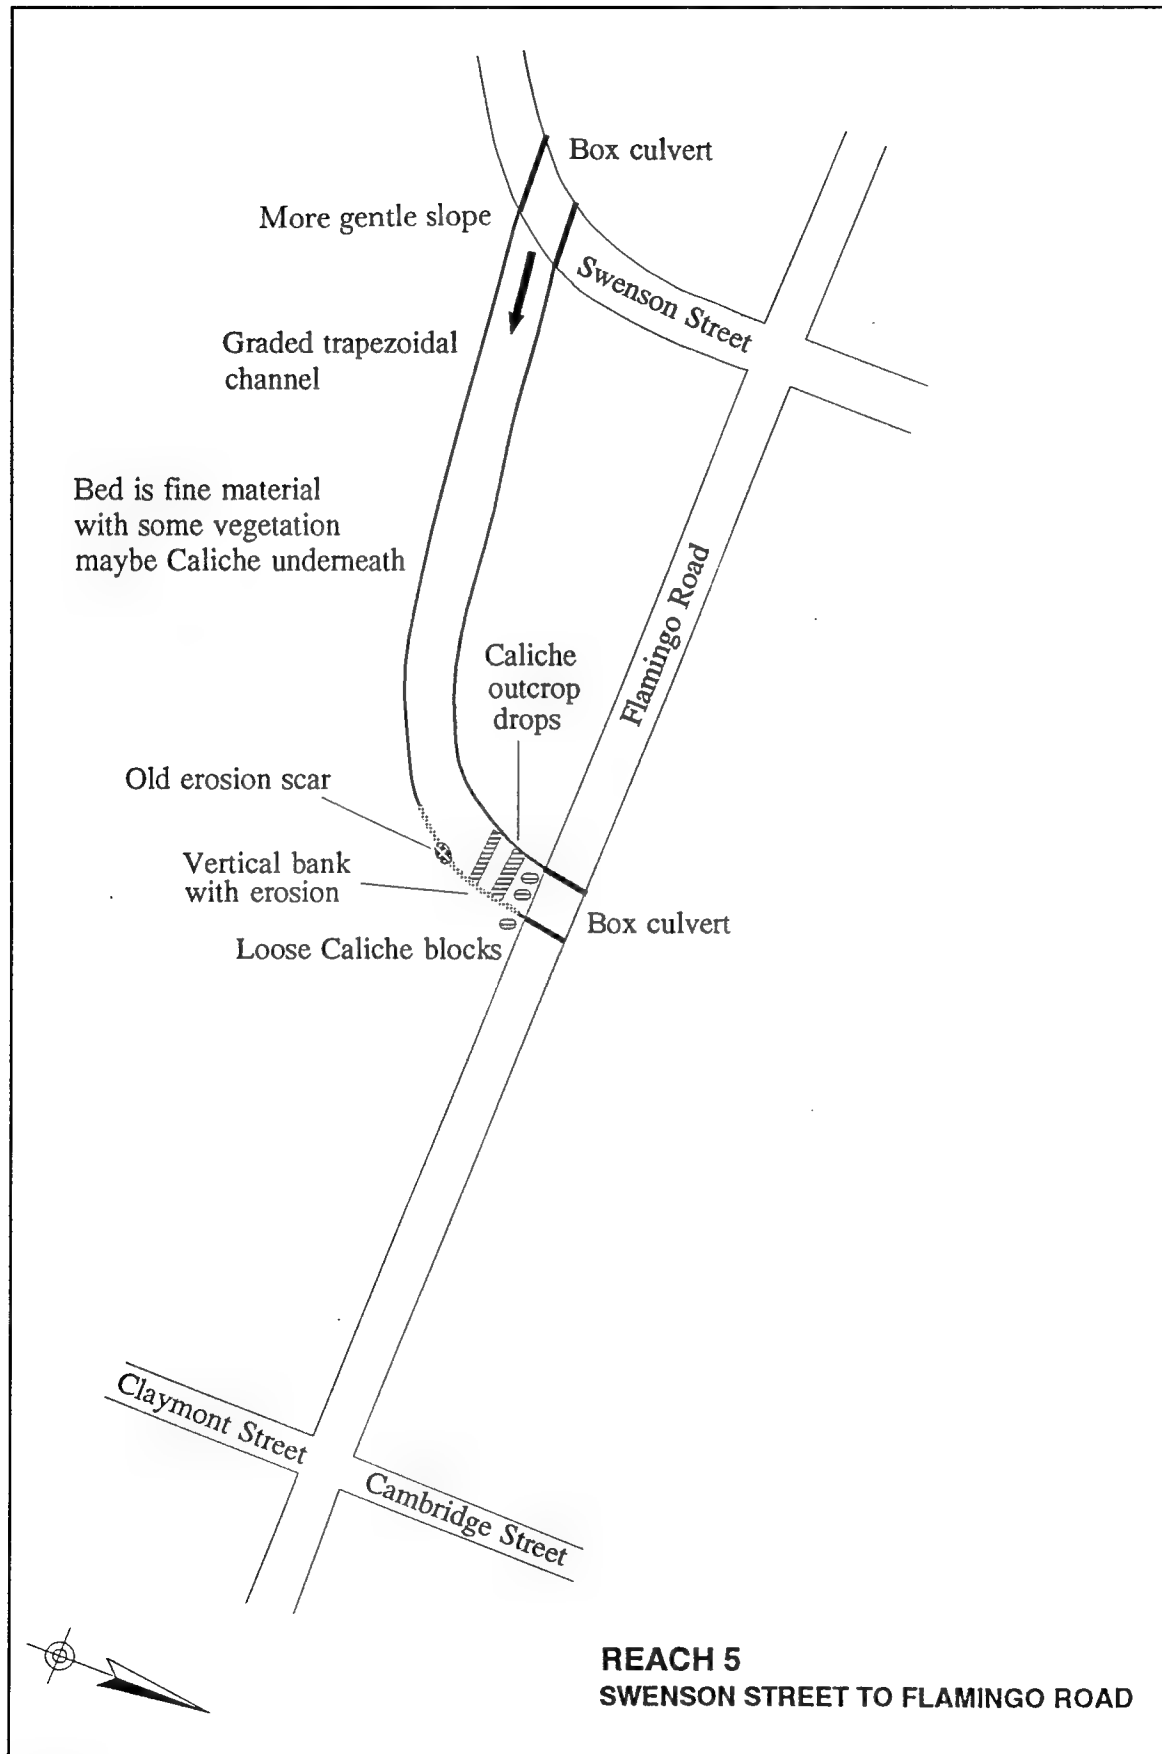
At Flamingo Road the channel entered a triple concrete-box culvert. Sloping pier noses should decrease the potential for floating debris build-up at the culvert entrance. Sediment deposits were observed in the culvert during the August 1994 field reconnaissance. About 6 to 12 inches of broken caliche and mud had deposited in the left bay. At the culvert exit, downstream from Flamingo Road, the natural channel bed was about 1 ft lower than the concrete invert. Plate 6 is a plan view sketch of the features in this reach.

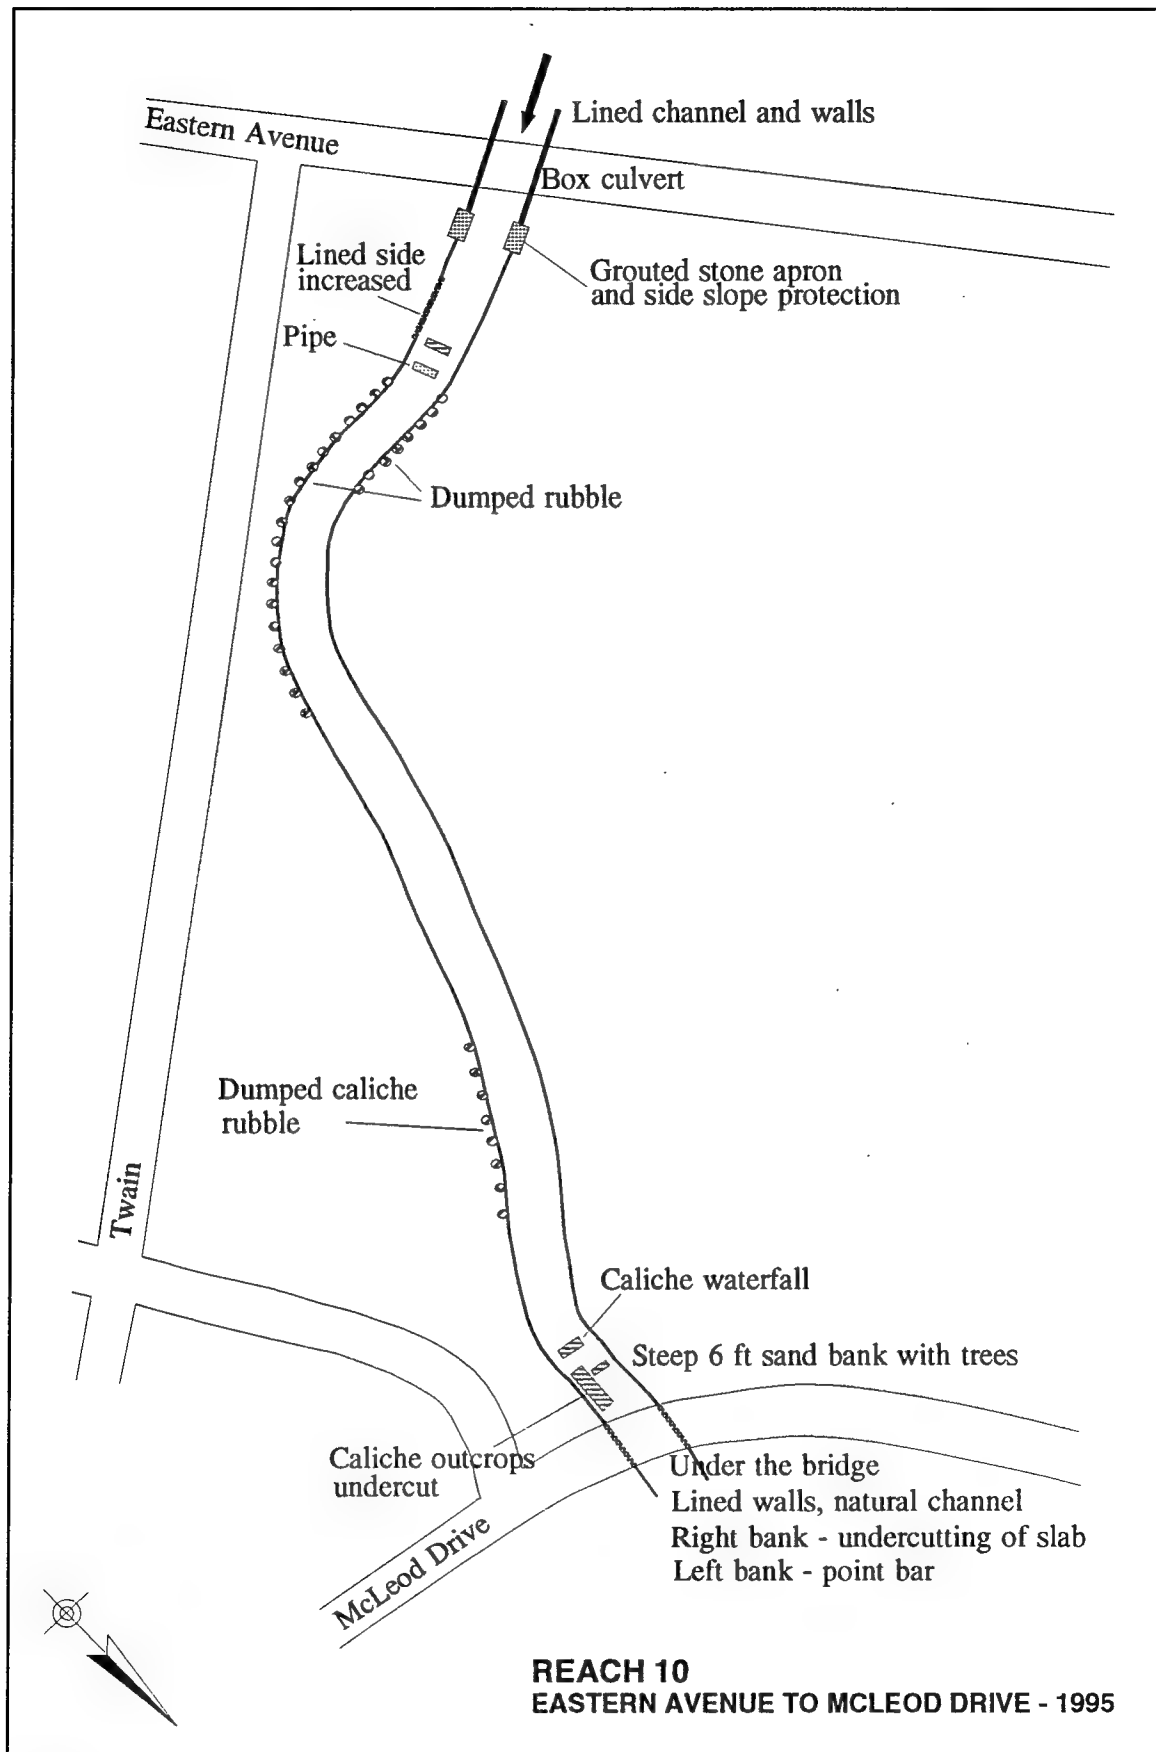
Plate 10

The bridge under McLeod Drive had concrete-lined side slopes and a natural invert. There was a gravel bar on the left bank, and undercutting of the slab on the right abutment was observed in August 1994. Evidence that repair work had occurred on the right abutment was observed. A plan view sketch of this reach is shown in Plate 10.

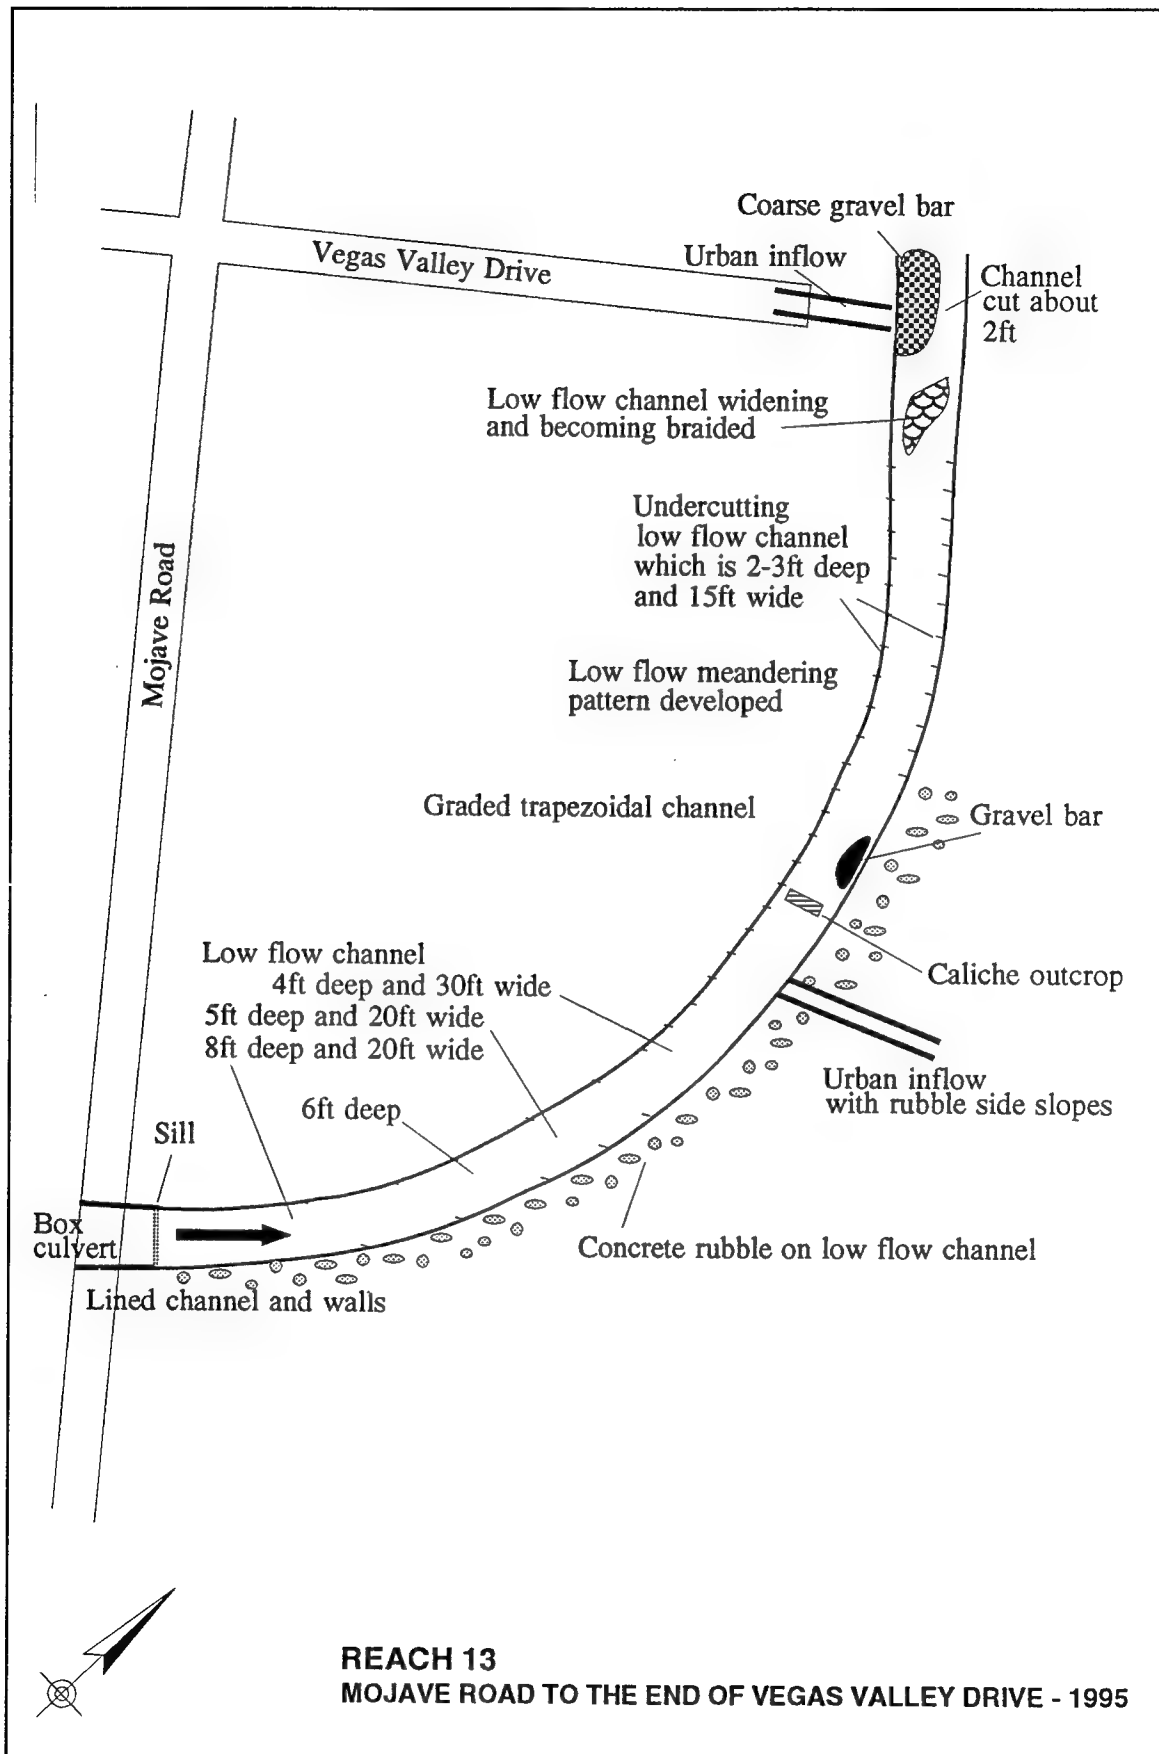
Downstream, towards Vegas Valley Drive, the low-flow channel widened and became shallower. The bed seemed to consist of a gravel mobile armor layer, and the bank material was unconsolidated. The notes in Plate 12 point out the variability of the low flow channel in this reach.
